## **Ali Qapu, Chehel Sutun, and Hasht Behesht**

*Isfahan, Iran*

## PROJECT SUMMARY

RESTORATION OF THE ALI QAPU  
CHEHEL SUTUN AND HASHT BEHESHT  
ISFAHAN, IRAN  
MAJOR RESTORATION COMPLETED 1977

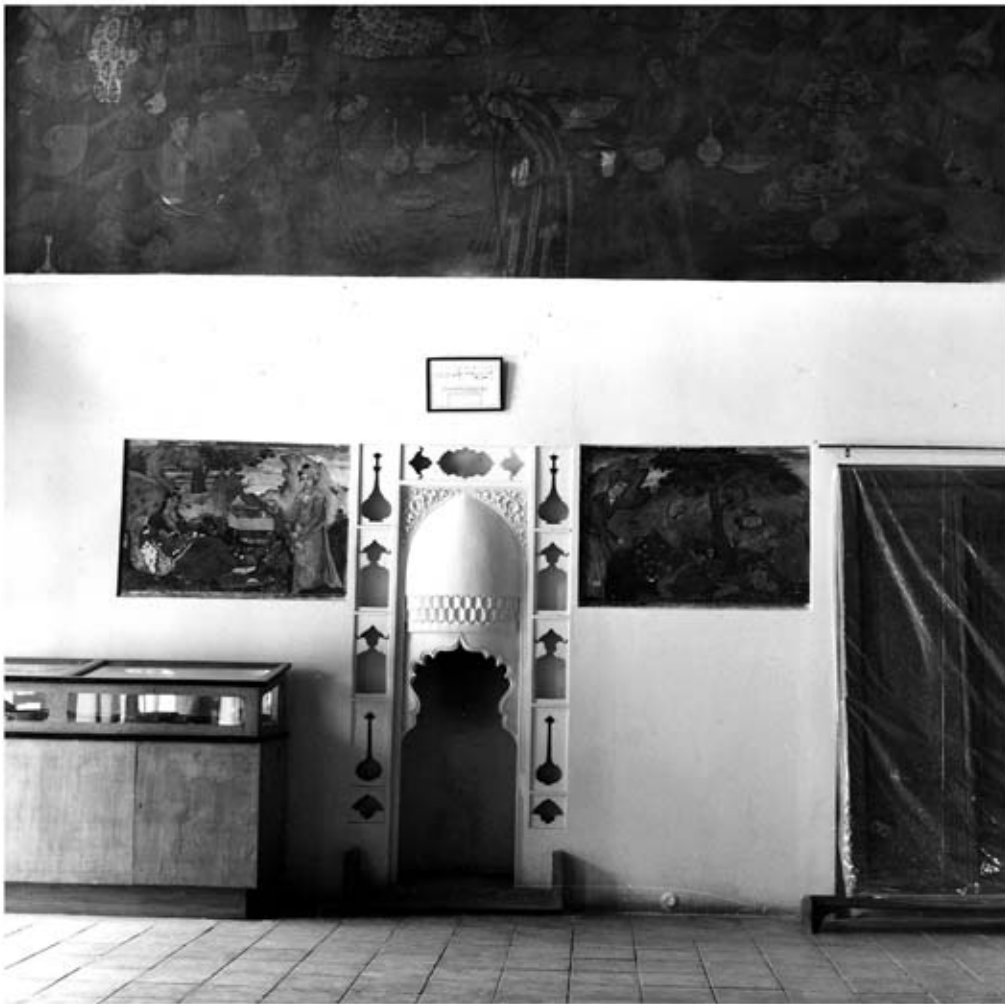
Central Hall before restoration, 1964

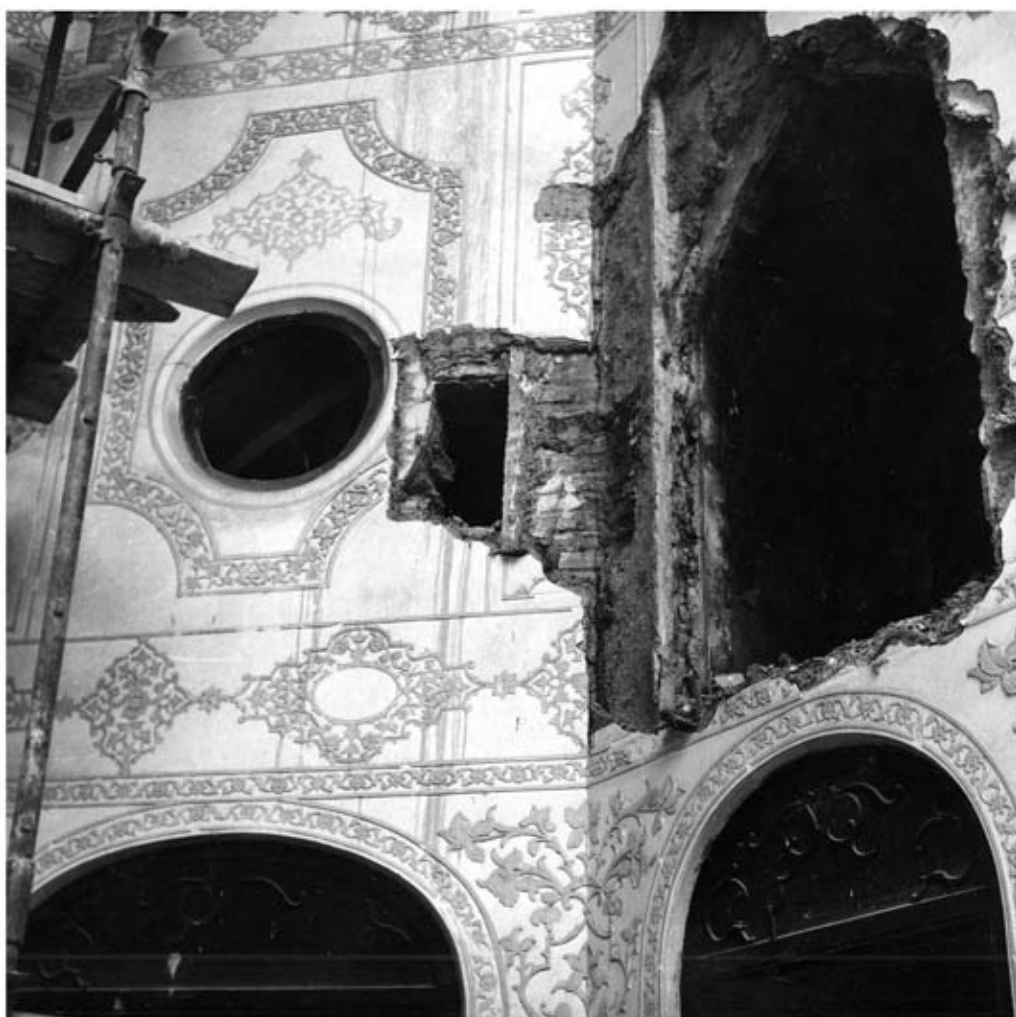
HASHT BEHESHT:  
before and during restoration

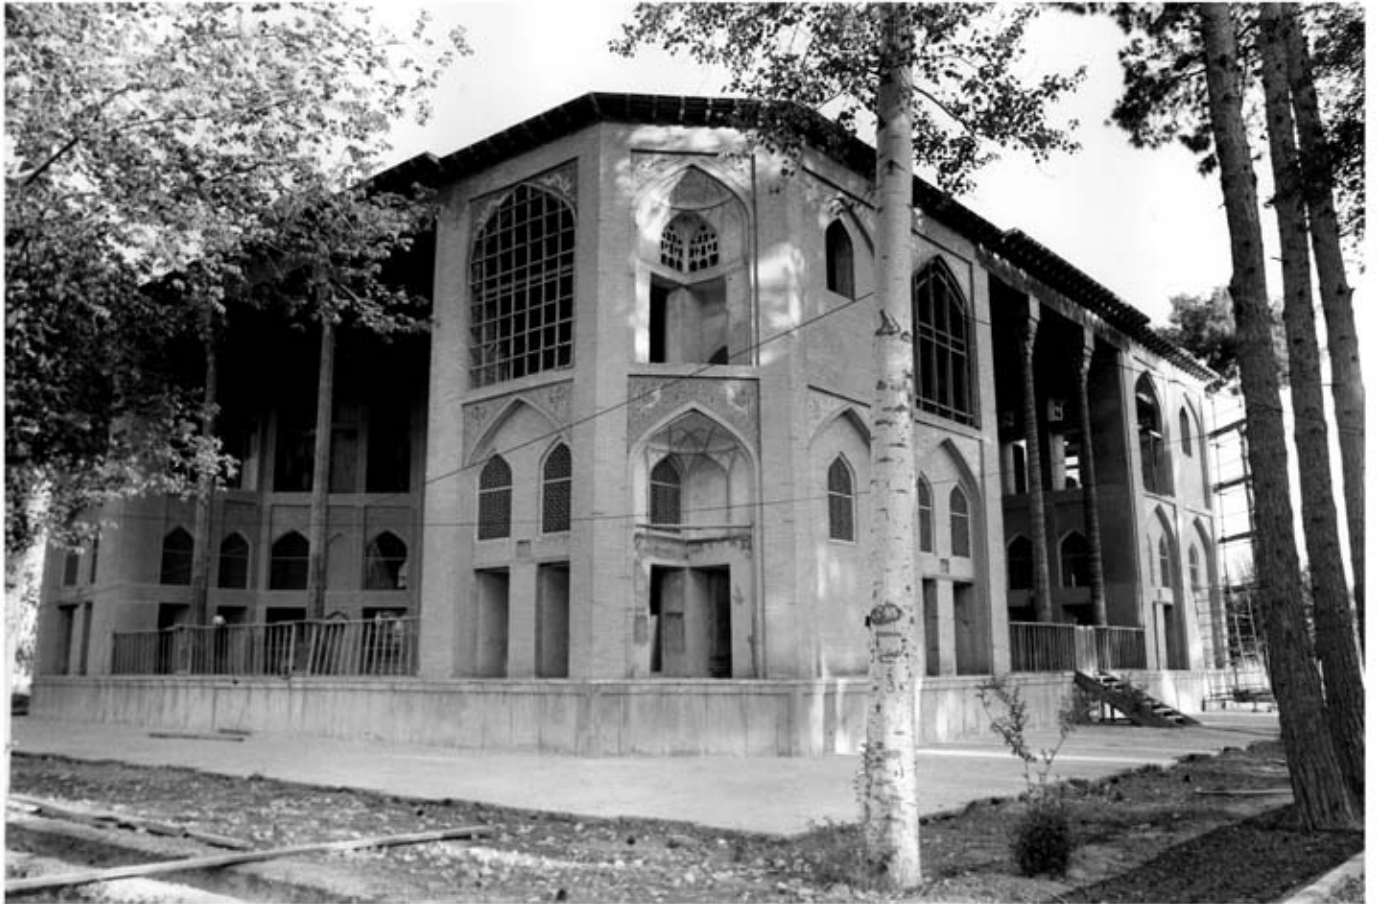
HASHT BEHESHT: during restoration

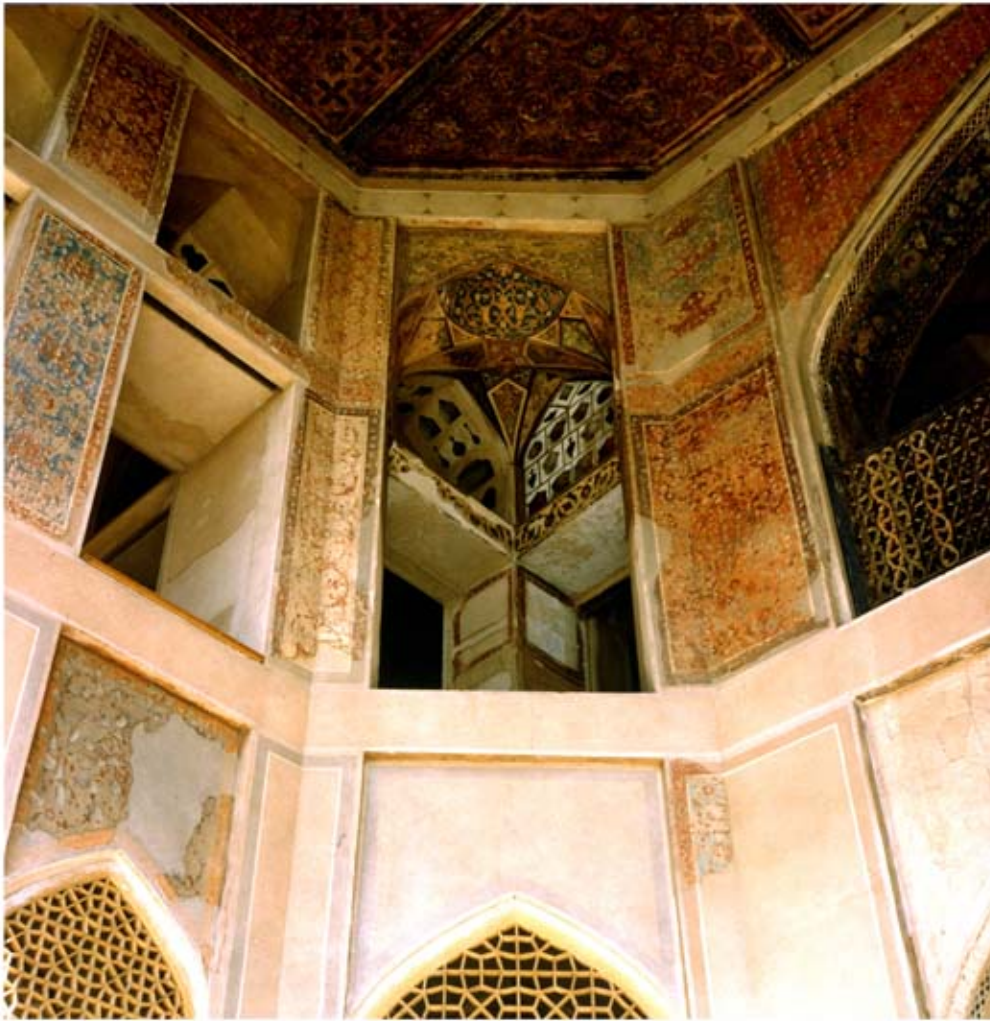
After  
restoration  
1980

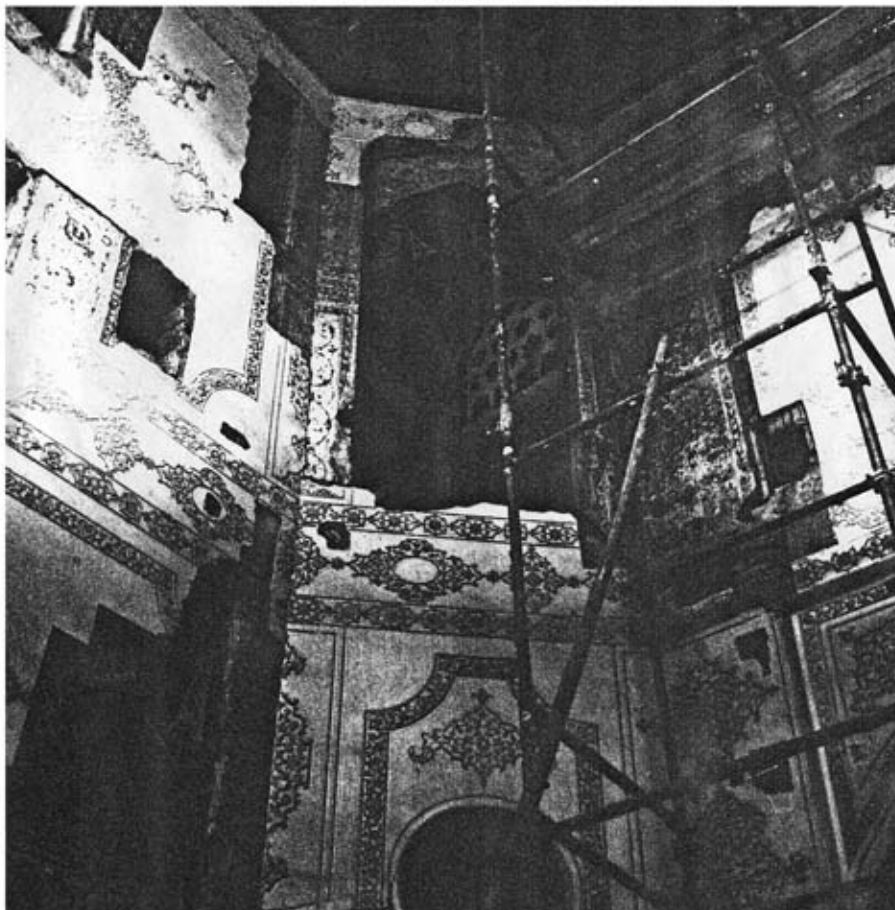
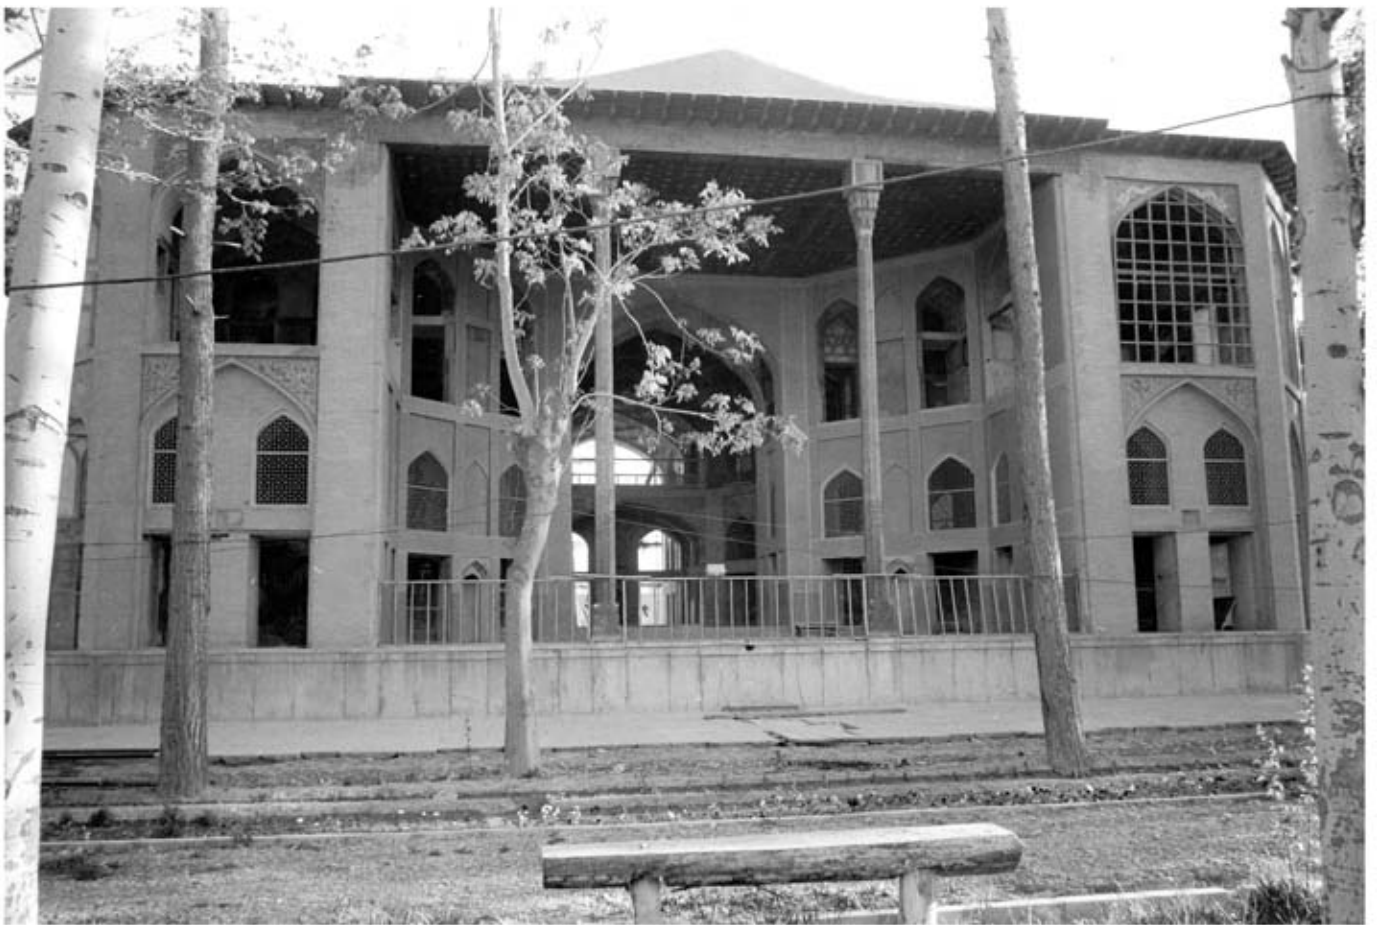
HASHT BEHESHT:

North eyvan, during and after restoration

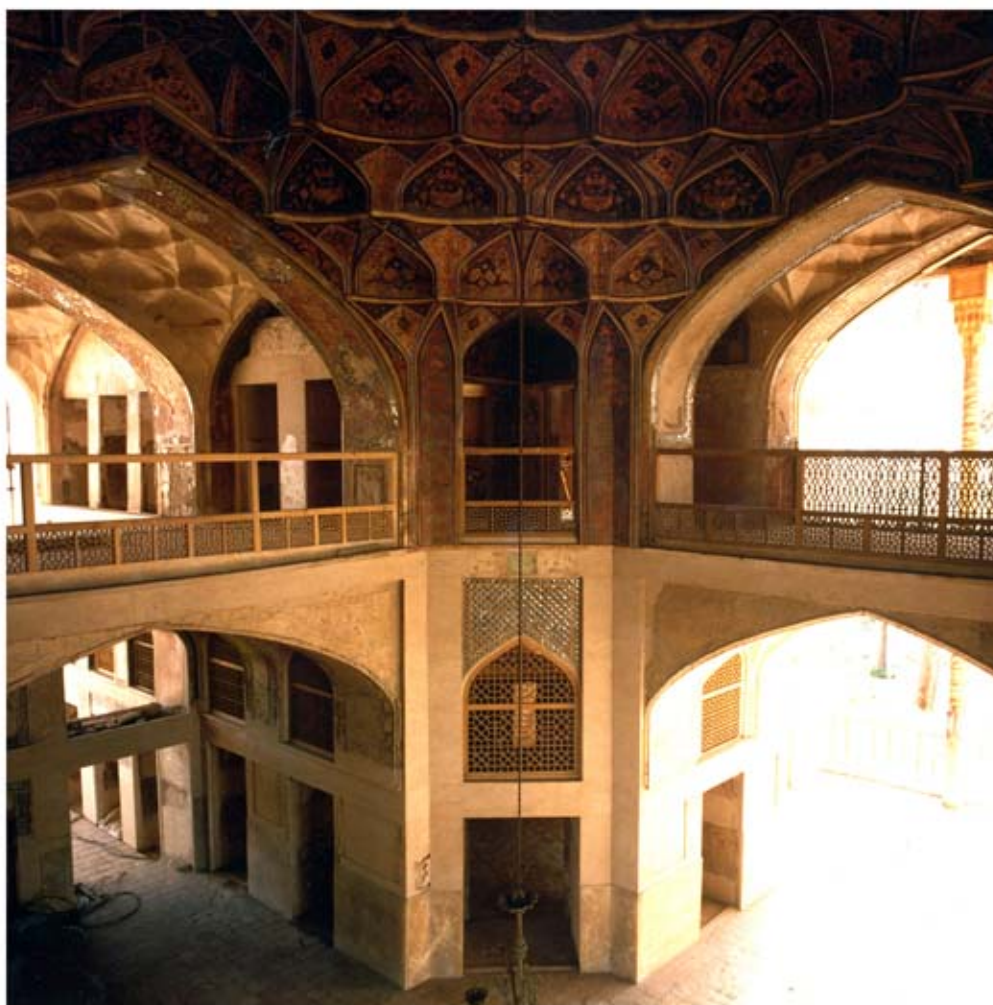
East eyvan  
during  
restoration

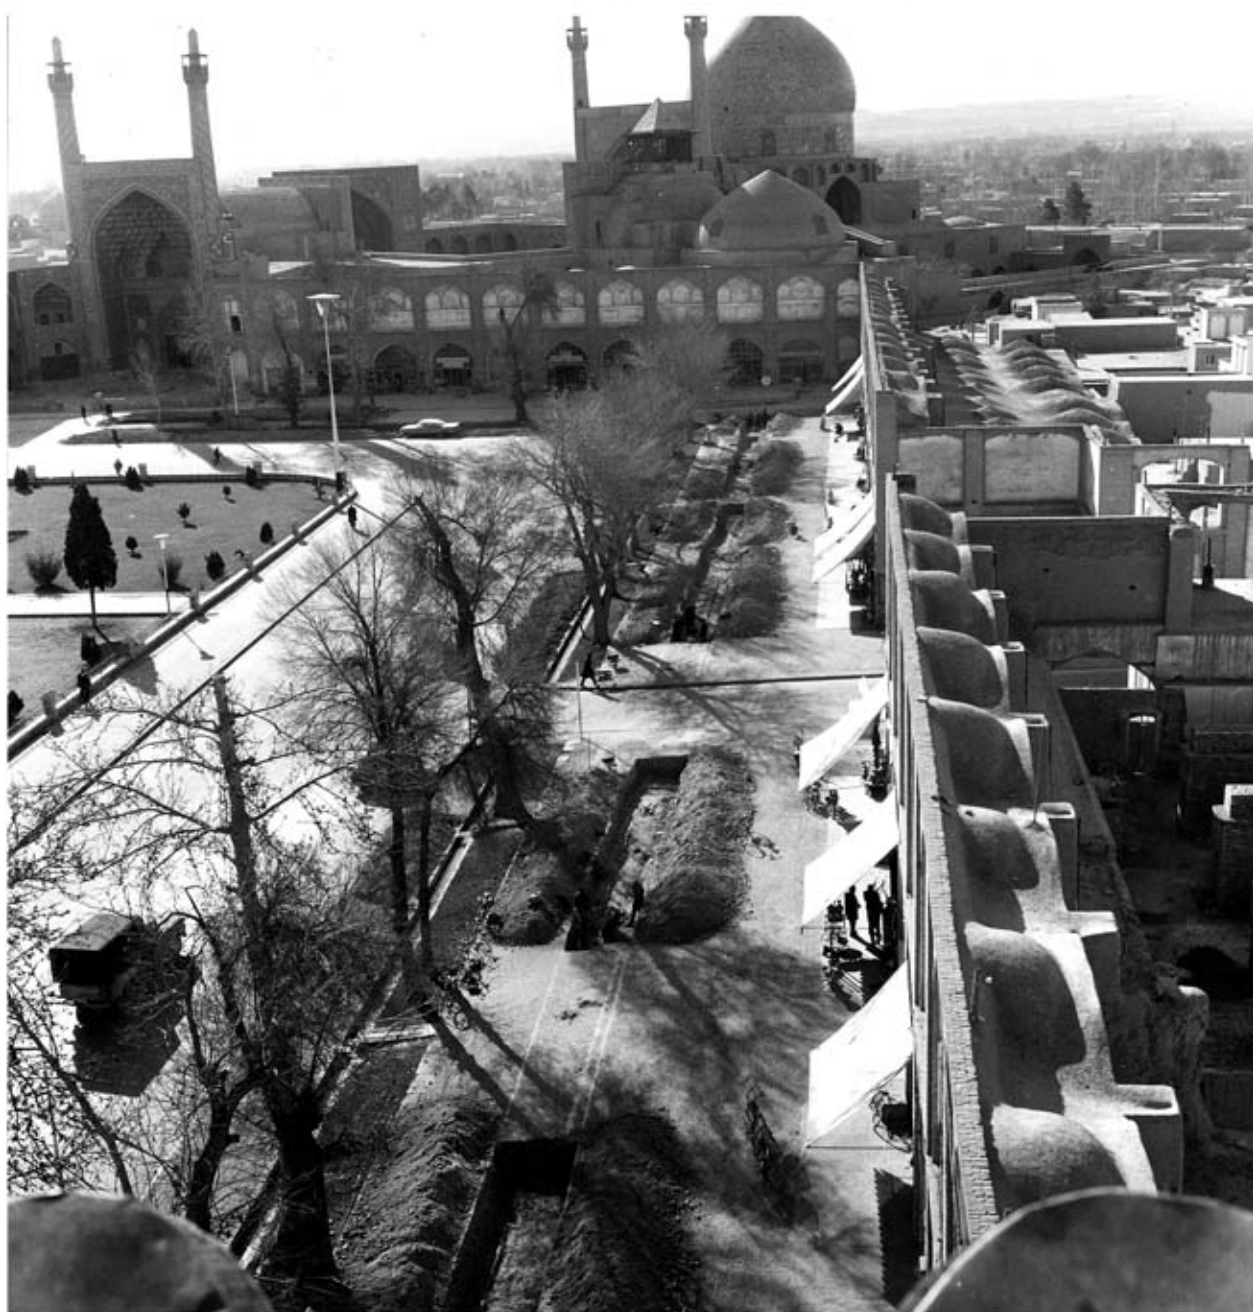
Maidan-i-Shah, restoring the Safavid bazaar, 1970

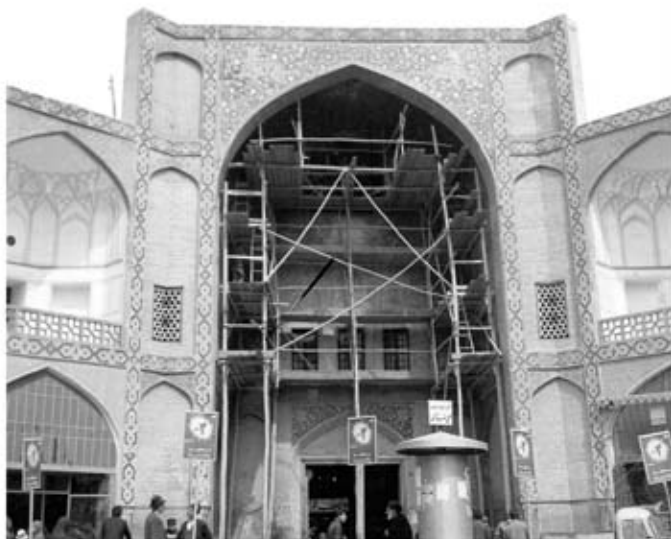
Rebuilding shops around the Maidan, 1973

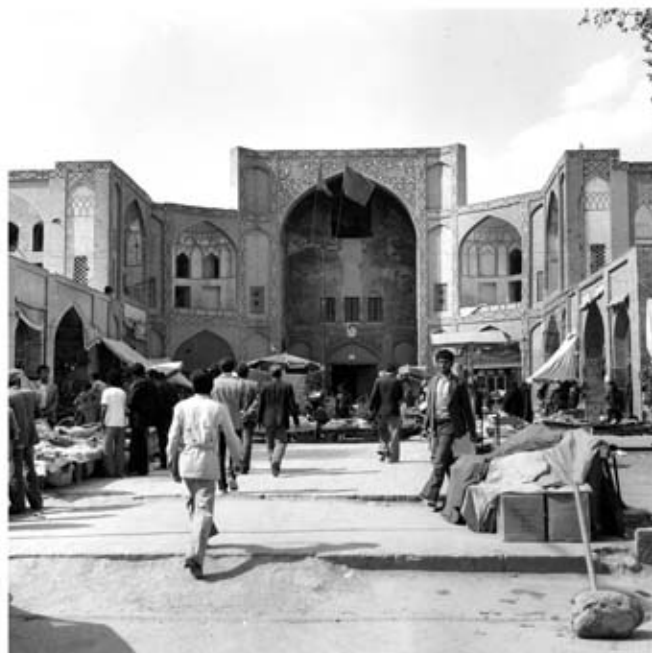
Bazaar Gate, during restoration, 1971

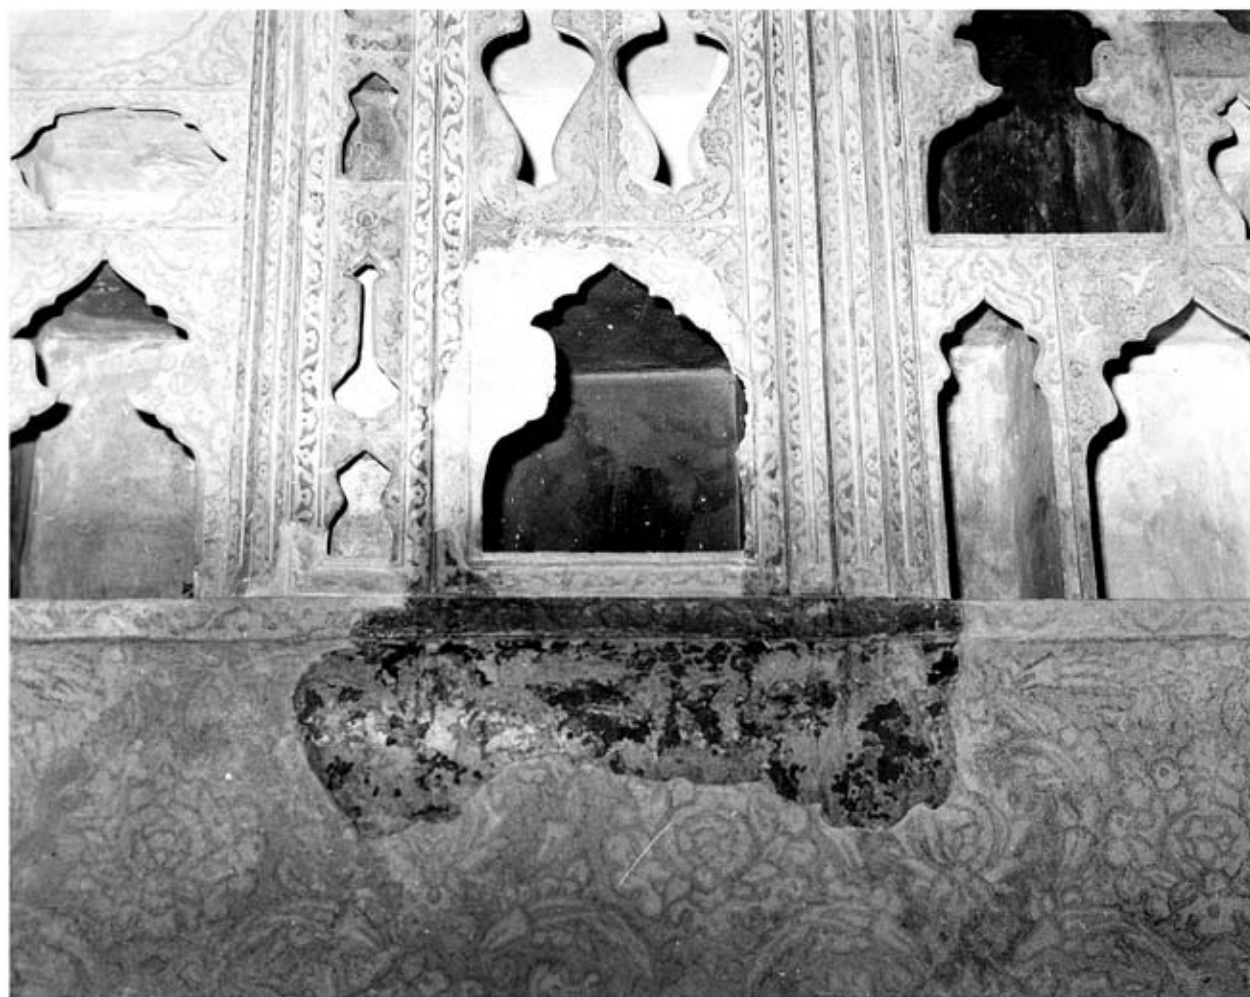
South facade during restoration, 1974

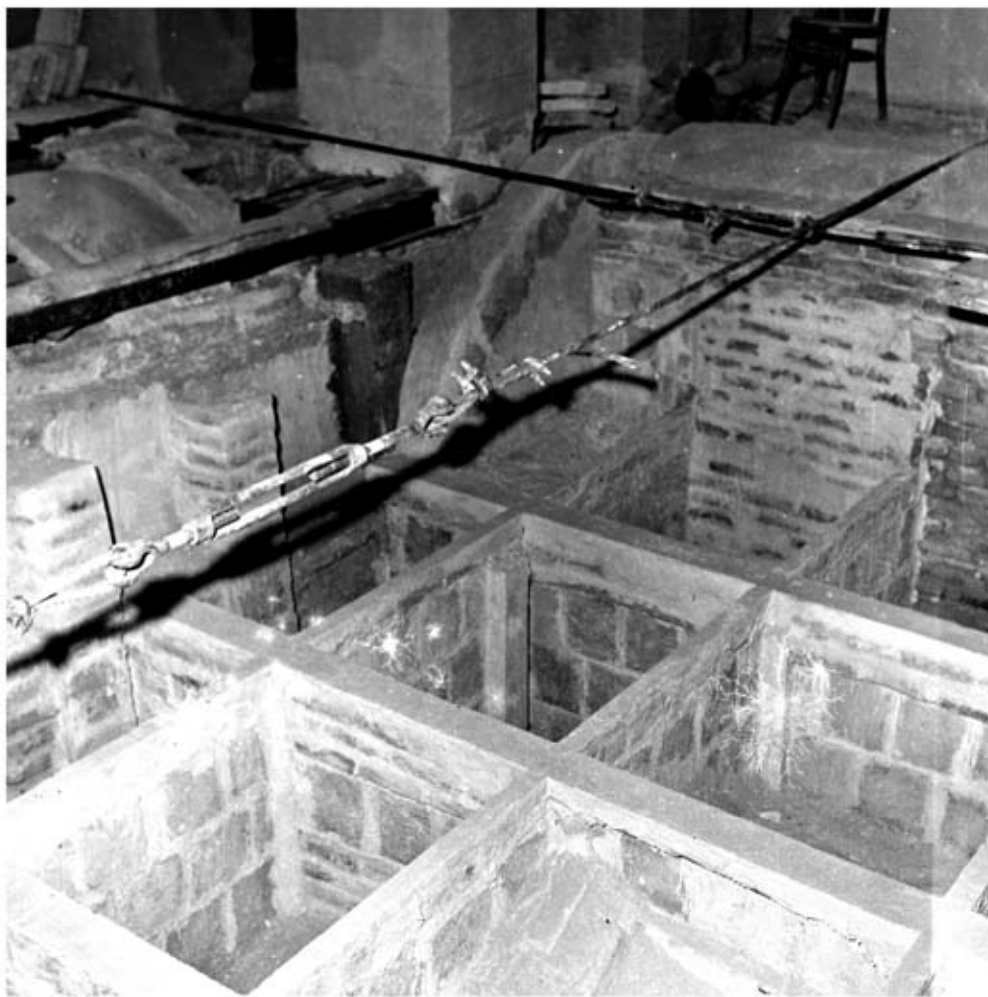
The Ali Qapu: before  
structural consolidation,  
1969

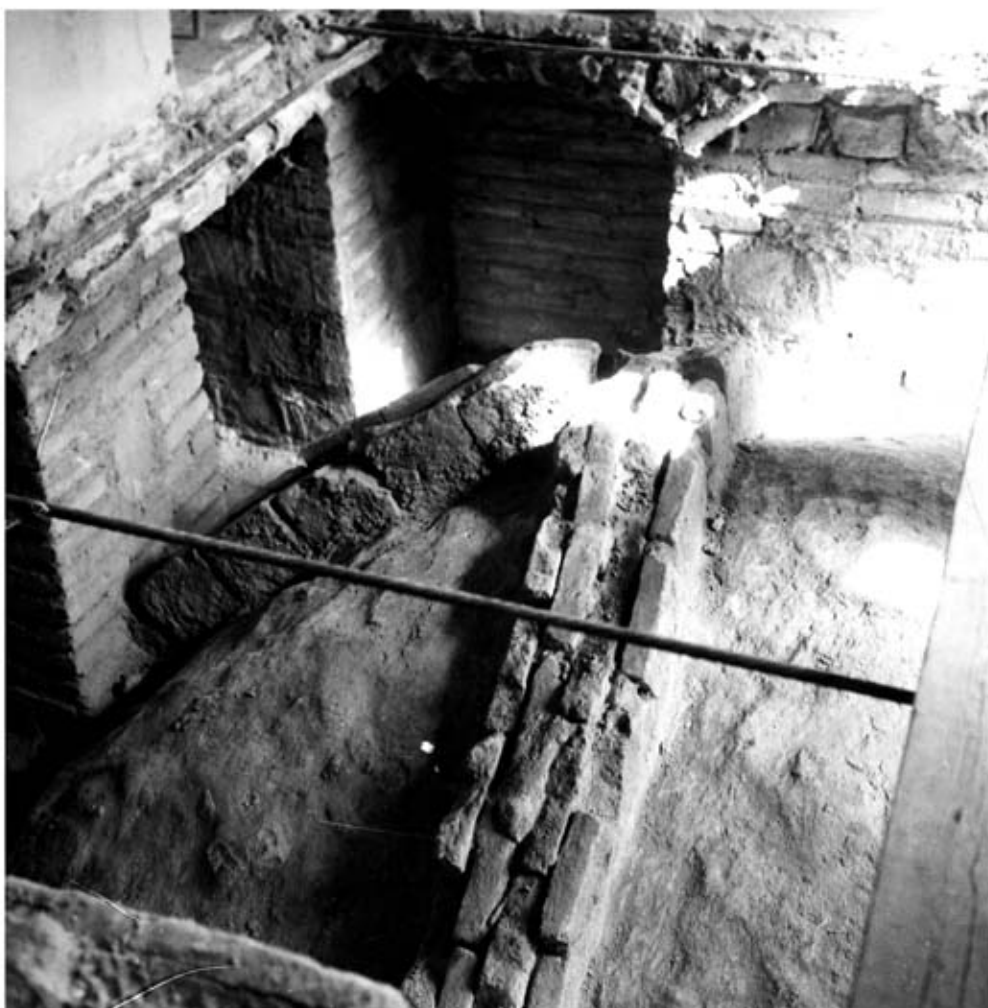
The Ali Qapu: before  
structural consolidation,  
1965

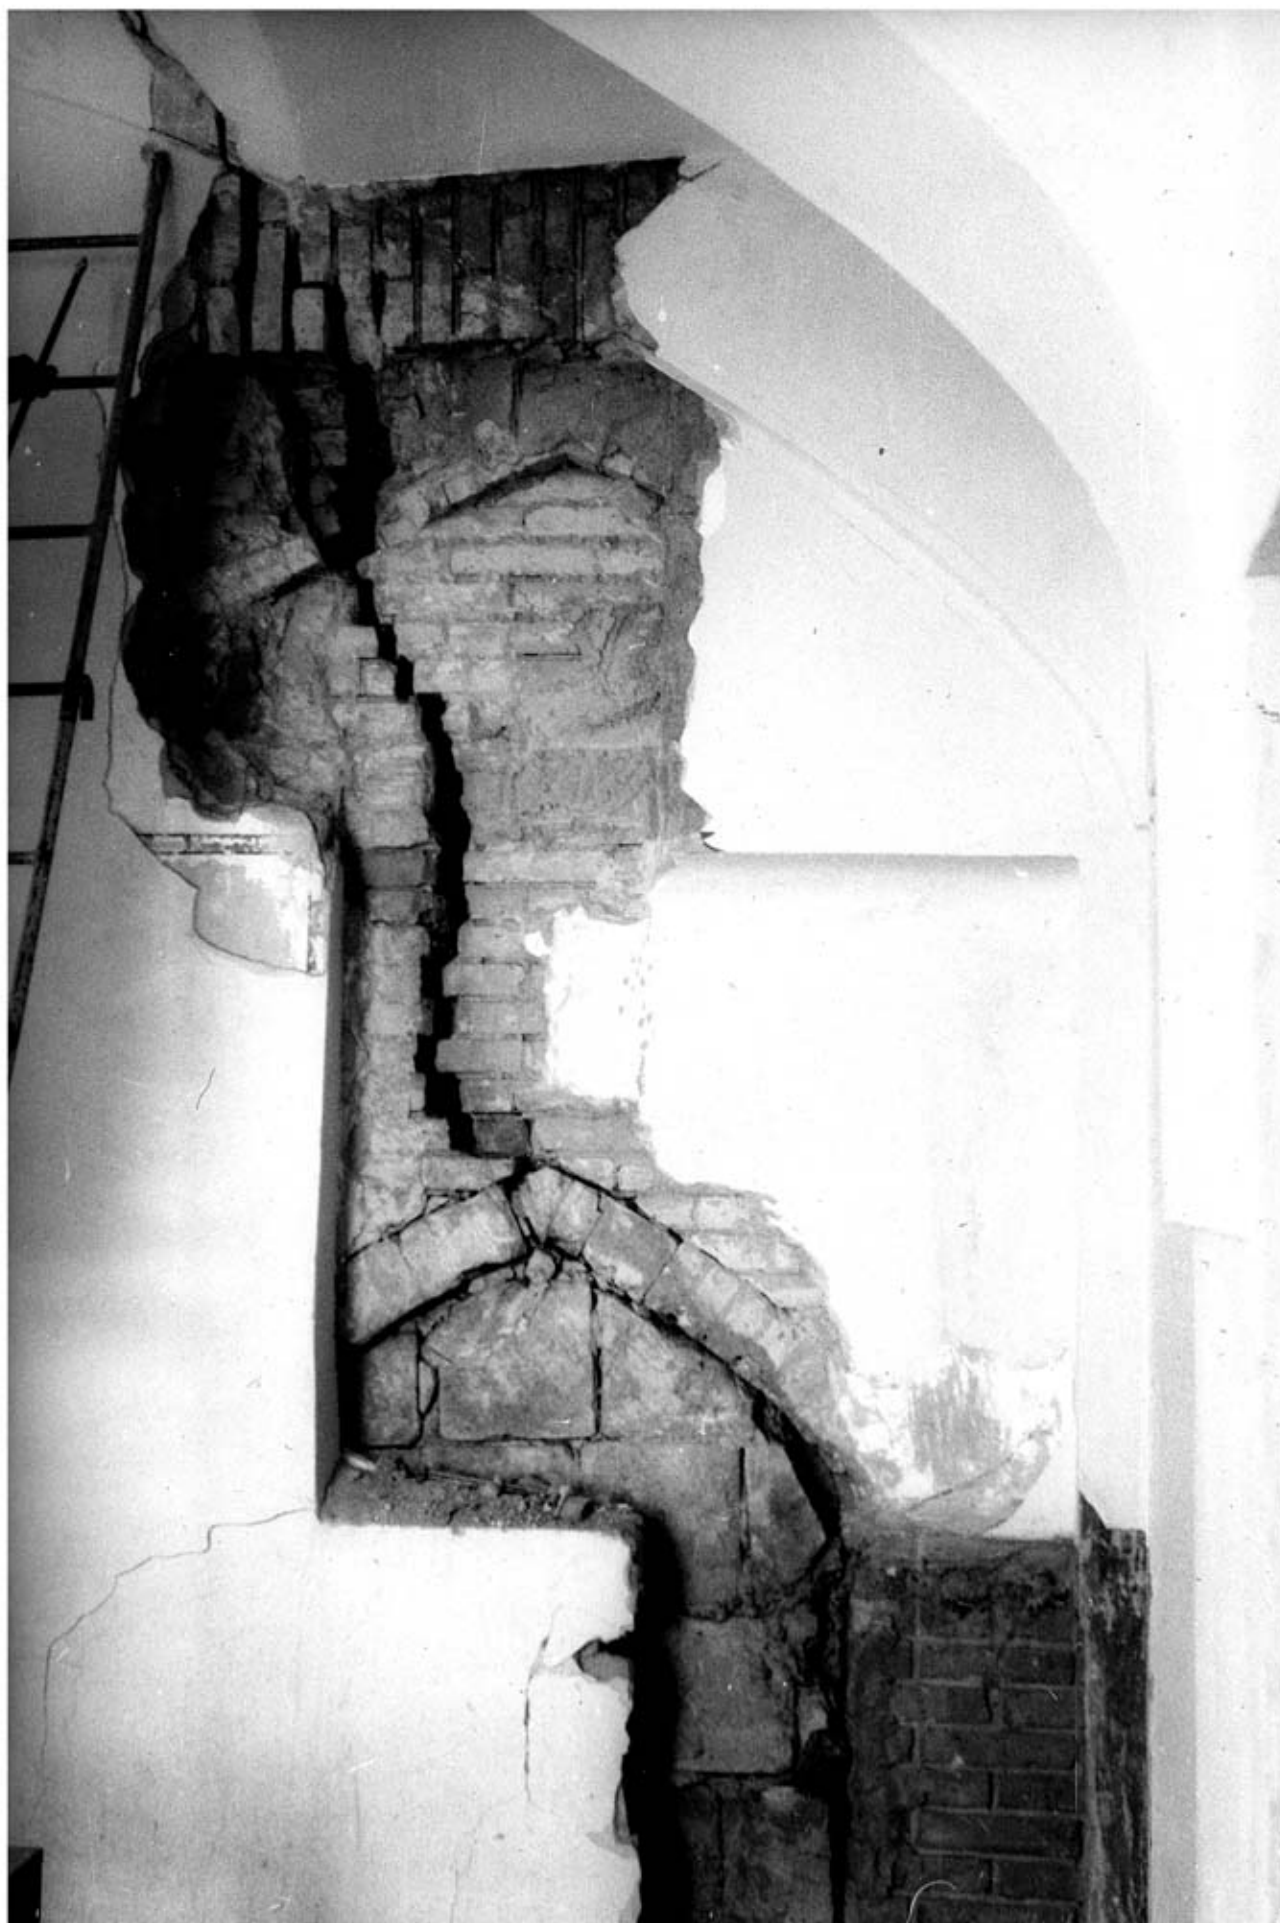
The Ali Qapu: crack in the entrance, 1967

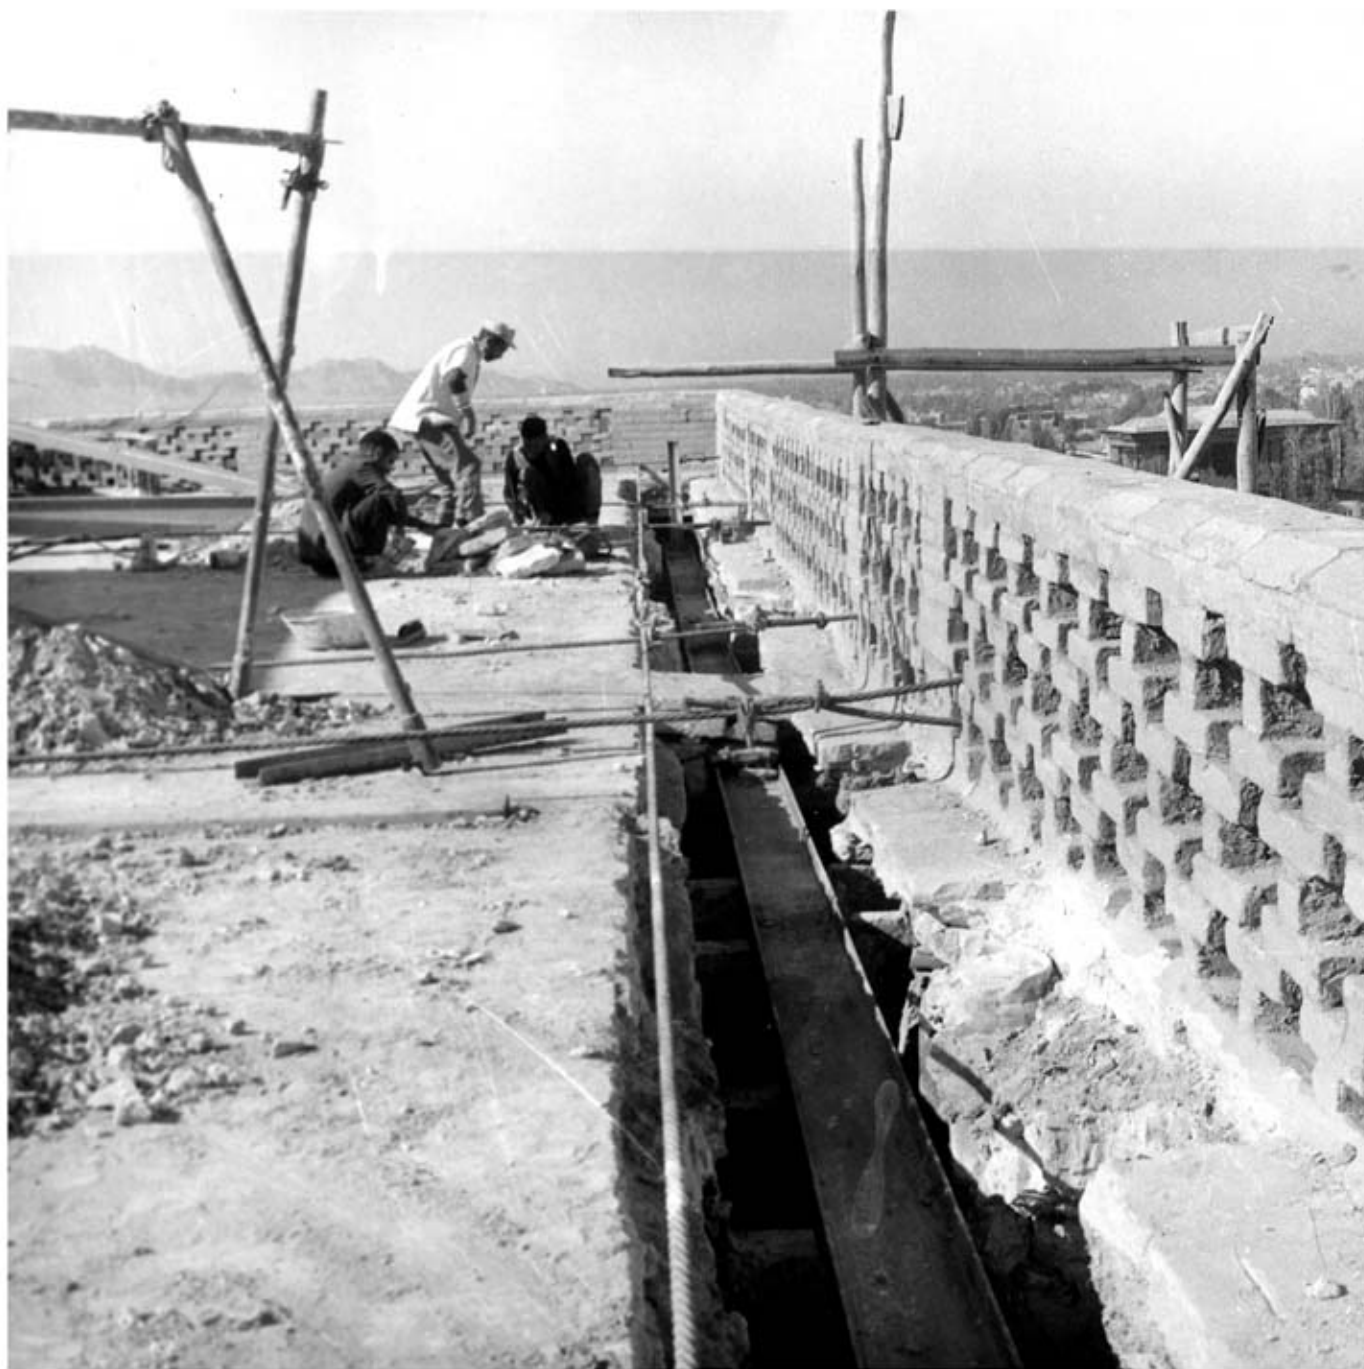
The Ali Qapu: structural consolidation, 1965
